**Pre Purchase Visual Timber Pest Inspection & Report AS 4349.3-2010**  
(For use in all States & Northern Territory but not the Australian Capital Territory)

216 Smixxx St, Glxxing Vaxxey, New South Wales, Australia

<b>Inspection Date:</b>	23-Jul-2016
<b>Report Prepared Date:</b>	23-Jul-2016

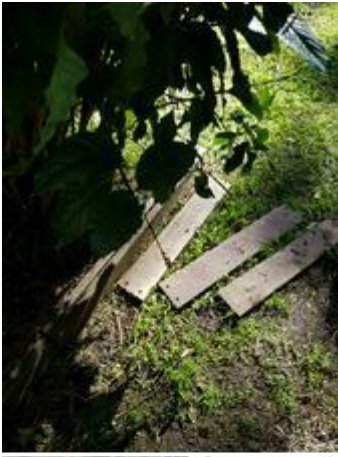
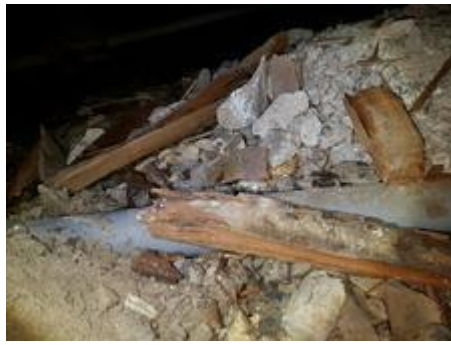
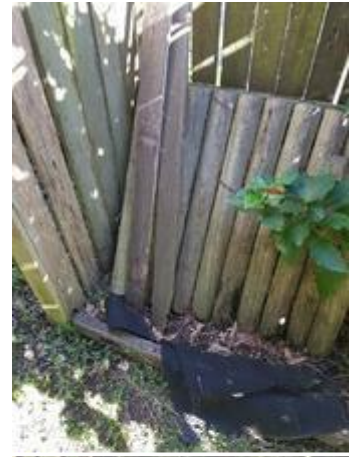
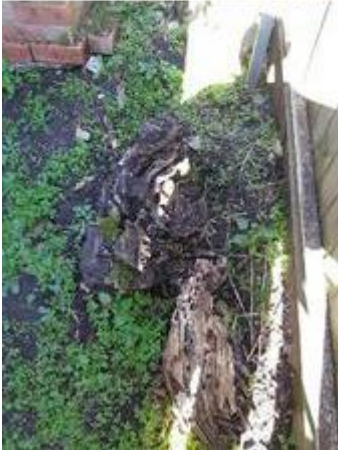
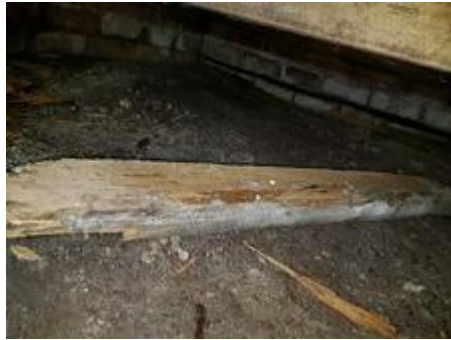
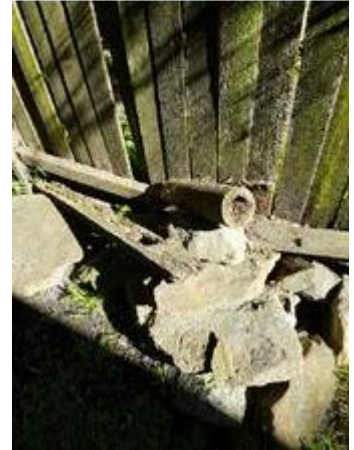
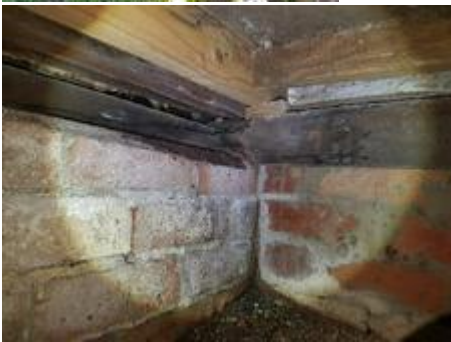
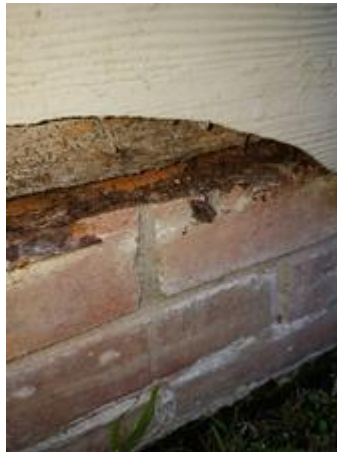
High Risk Area Photos

<b>High Risk Area(s) to which Access <u>should</u> be gained, or fully gained, since they may show evidence of Timber Pests or damage include:</b>	The Interior, The edge of the concrete slab, The weep holes, The fences, The retaining walls
--	--

Further Inspections are strongly recommended to areas where Reasonable Access is Unavailable, Obstructed or Restricted or a High Risk of possible Timber Pests and /or Damage exists.

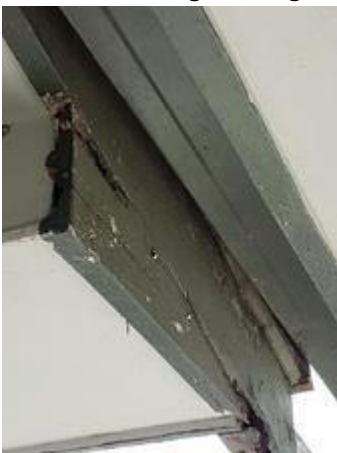
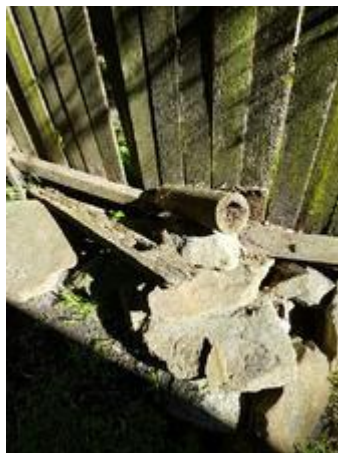
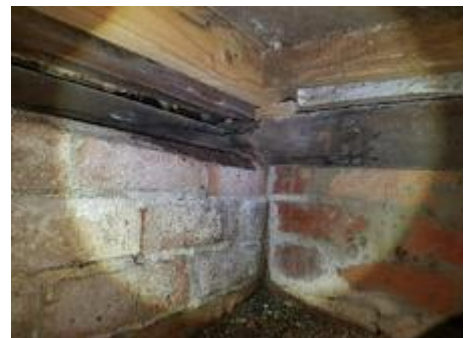
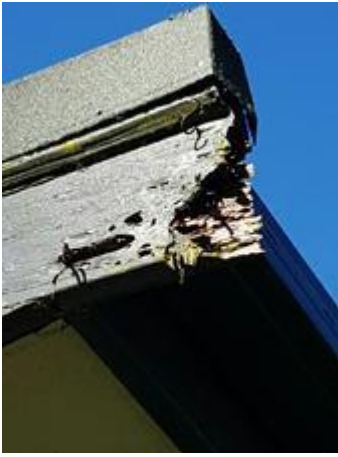
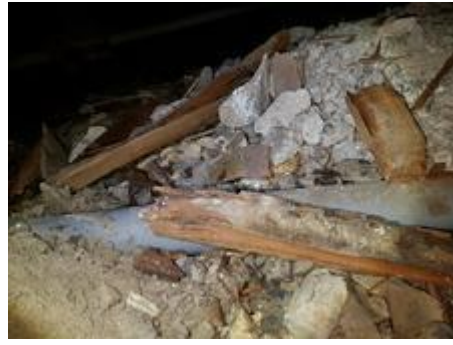
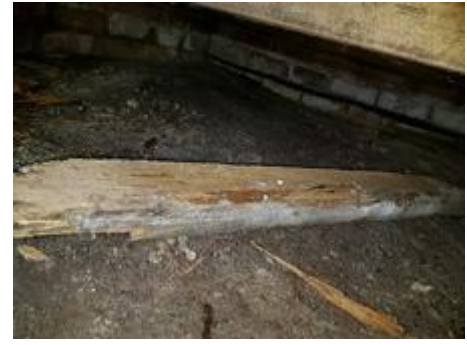
**Photo of Workings/Damage**

<b>Visible evidence of subterranean termite workings and/or damage</b>	was found
<b>Where workings and/or damage was found, it was in but not necessarily limited to the following areas:</b>	Subfloor, Posts, Fences, Timber retaining walls

Where visual evidence of termite workings and/or damage is reported above, but no live termites were present at the time of inspection, you must realise that it is possible that termites are still active in the immediate vicinity and the termites may continue to cause further damage. It is not possible, without benefit of further investigation and a number of inspections over a period of time, to ascertain whether any infestation is active or inactive. Active termites may simply have not been present at the time of inspection due to a prior disturbance, climatic conditions, or they may have been utilising an alternative feeding source. Continued, regular, inspections are essential. Unless written evidence of a termite protection program in accord with "Australian Standard 3660" with ongoing inspections is provided, you must arrange for a treatment in accord with "Australian Standard 3660" to be carried out immediately to reduce the risk of further attack.

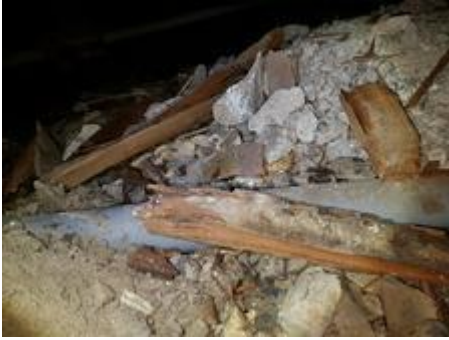
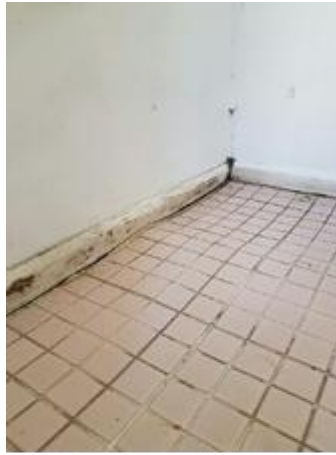
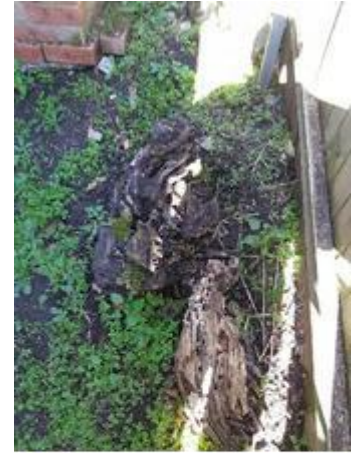
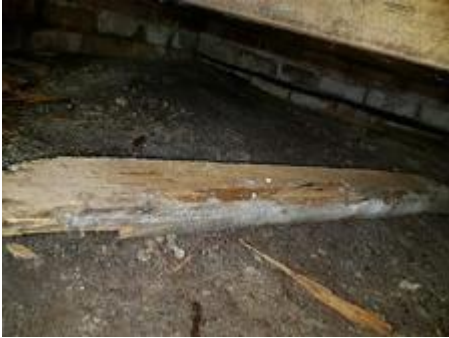
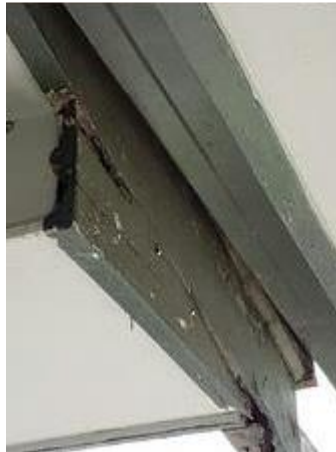
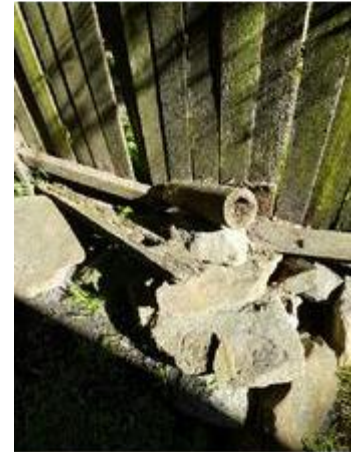
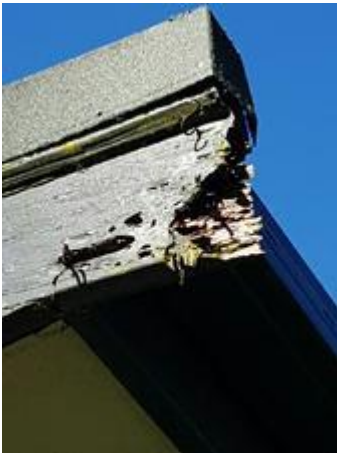
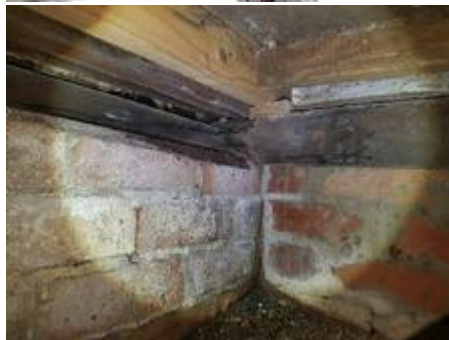
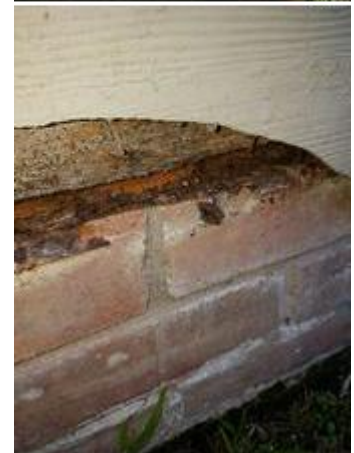
**Wood Rot Photos**

Was evidence of wood decay fungi (wood rot) found?	Yes. Found in subfloor, fences, and internal areas to laundry
--	--

We claim no expertise in building and if any evidence of fungal decay or damage is reported you should consult a building expert to determine the full extent of damage and the estimated cost of repairs or timber replacement (See Terms & Limitations).

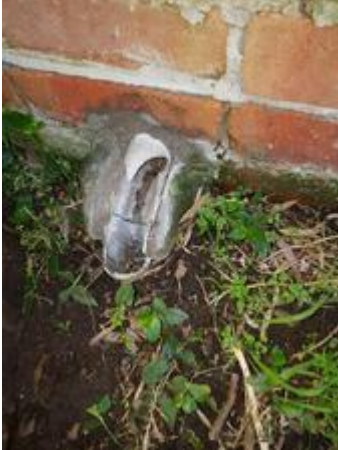
<b>At the time of the inspection</b>	leaks were found to be present in External piping
--------------------------------------	---

Broken pipes

We claim no expertise in building and if any leaks were reported then you must have a plumber or other building expert determine the full extent of damage and the estimated cost of repairs.

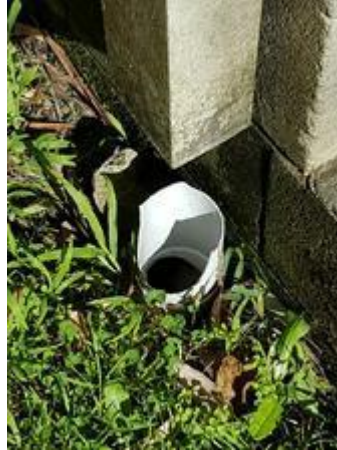
Broken pipes

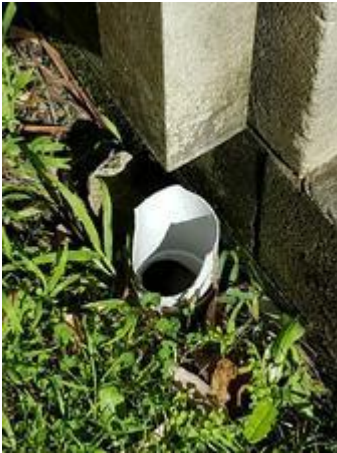
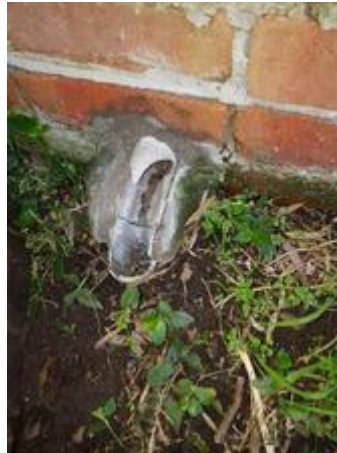
### Drainage Photos

<b>We claim no expertise in plumbing and drainage, however it appears that drainage is generally</b>	inadequate. Very high moisture in subfloor water was present at the time of inspection
--	--

Where drainage is considered inadequate a plumber, builder or other building expert must be consulted.

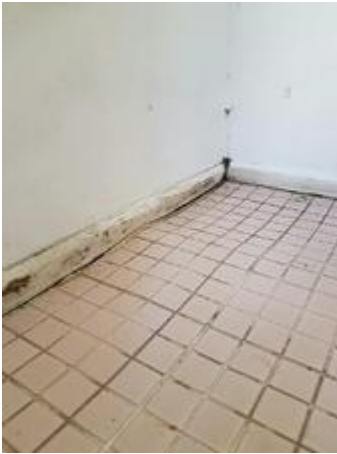
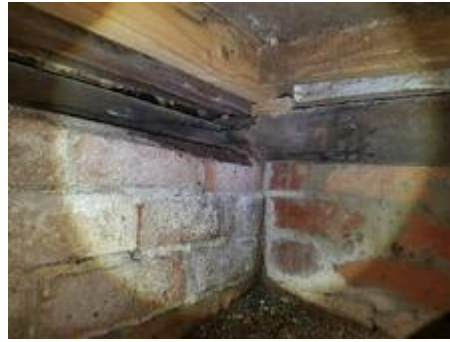
### Mould Photos

<b>Mould</b>	was found in the following area(s):. Laundry, hallway, subfloor
--------------	---

**Mould** on walls and ceilings etc; is an indicator of high moisture or very poor ventilation. If reported You need to have the reason investigated by a builder or a Industry Hygienist as its presence may indicate the presence of a water leak, wood decay or termites behind the wall or ceiling sheeting.

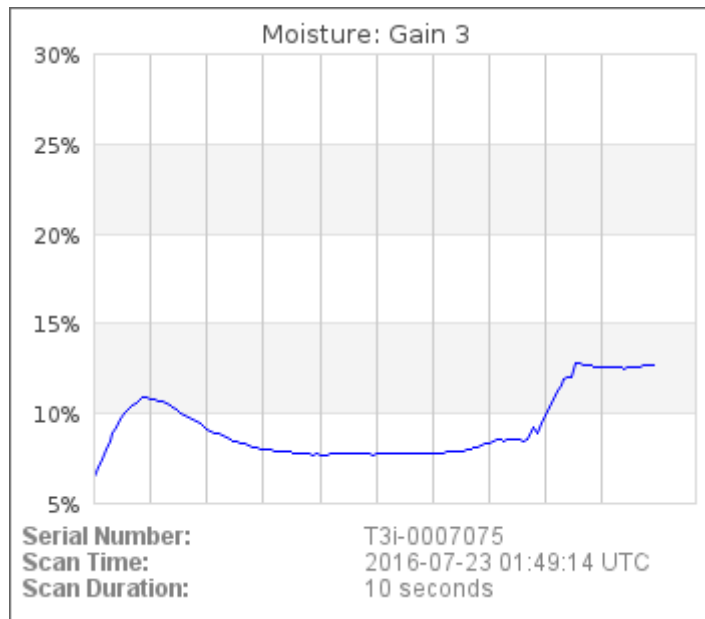
## 1.1 Moisture Scan

Moderate Moisture

**Scan Location:** Interior/Ground/Dining  
**Termatrac device was:** Handheld  
**Termatrac device position:** Flush against surface  
**Damage Visible:** No

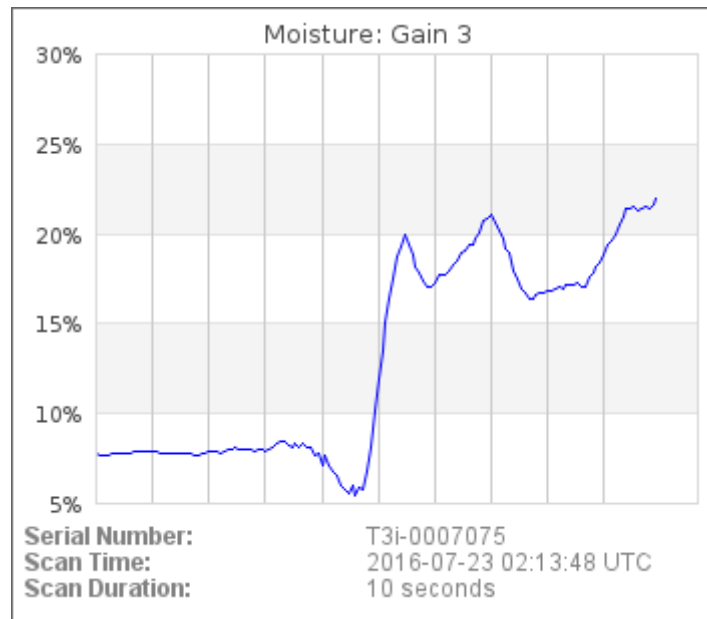
### 2.1 Moisture Scan

high moisture noted in walls

**Scan Location:** Interior/Ground/hallway  
**Termatrac device was:** On a solid platform  
**Termatrac device position:** Flush against surface  
**Damage Visible:** No

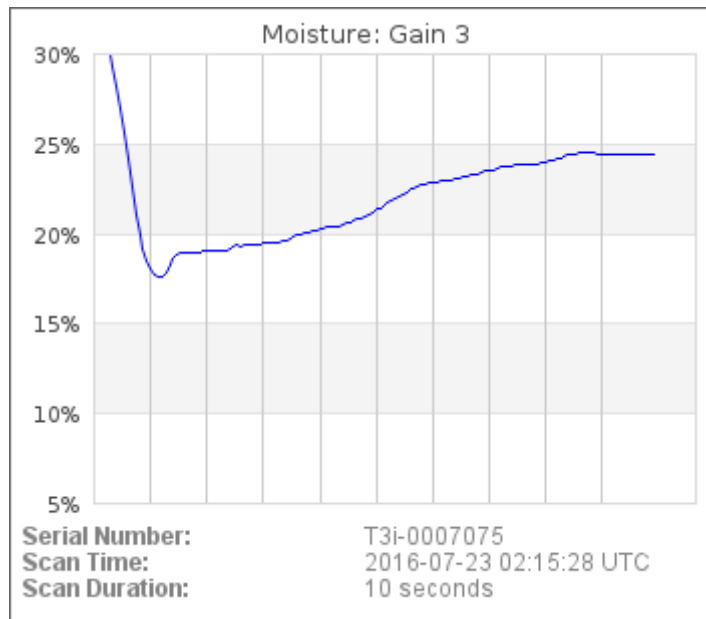
#### 3.1 Moisture Scan

high moisture noted

**Scan Location:** Interior/Ground/Laundry  
**Termatrac device was:** Handheld  
**Termatrac device position:** Flush against surface  
**Damage Visible:** Yes

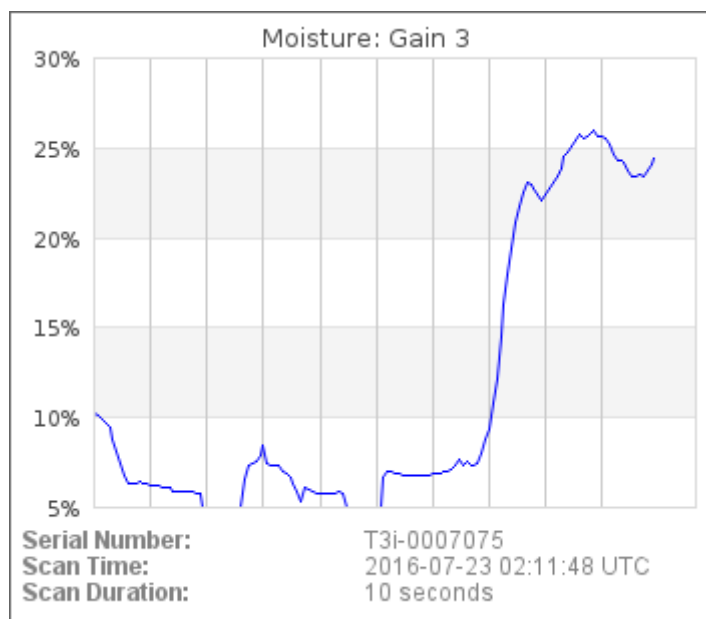
#### 3.2 Moisture Scan

high moisture Noted in walls

**Scan Location:** Interior/Ground/Laundry  
**Termatrac device was:** Handheld
