Visual Termite Inspection & Report in Accordance with AS 3660.2-2000

1243 Smith Pl, Never Never Land NSW, Australia

Visual Termite Inspection Report in accordance with AS 3660.2-2000

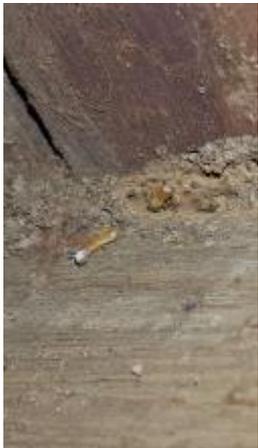
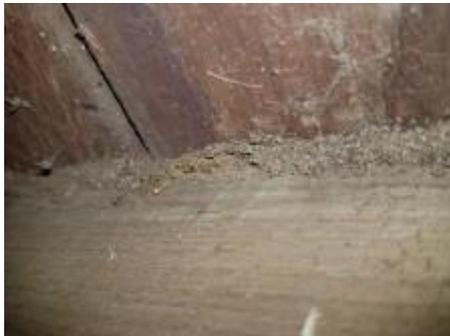
At the time of the inspection were active termites (live insects) found?	Yes
Active termites were located in but not necessarily limited to the following areas:	Subfloor

If the answer was "Yes" then the termites are believed to be	Coptotermes Spp.
---	------------------

Live Termite to Bearer and Mudding to Joist

Subterranean termite treatment recommendation: A suitable management program that accords with AS 3660 against subterranean termites is considered to be	Essential
---	-----------

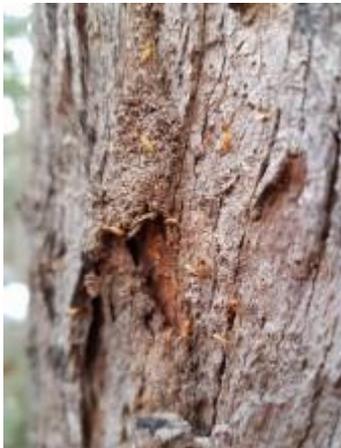
(If yes, describe & state the location): Aborial nest found up in tree facing front door

Live Activity Noted To Tree

Environmental, other Conditions and/or general information: Recommend test drilling of all trees within 30-50mtr be essential as workings are visible as well as fly cuts. Recommend removing coated metal roofing for inspection as alates have been found around the house.

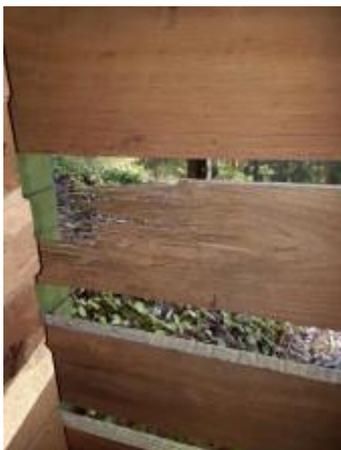
Wood rot: At the time of the inspection was visible evidence of wood decay fungi (rot) found?	Yes
Evidence was found in	Subfloor, Wall Exterior, Decking Front, Bathrooms

Decay and old damage to sub floor fence

Wood decay fungi are conducive to subterranean termites. You should consult a builder or other building expert to find out what must be carried out to prevent further decay (repairing of drainage, leaks and/or sealing the timber) and to repair the damage.
