TERMATRAC TEST REPORT **SUPPLEMENT TO TIMBER PEST REPORT**

This Termatrac® test report is a supplementary report only, which **MUST** be read in conjunction with the full timber pest report dated 14th June 2016. This report cannot be relied upon without the full timber pest report and is only a record of the test findings

Report for building at: 243 Smith Place jillibynsw

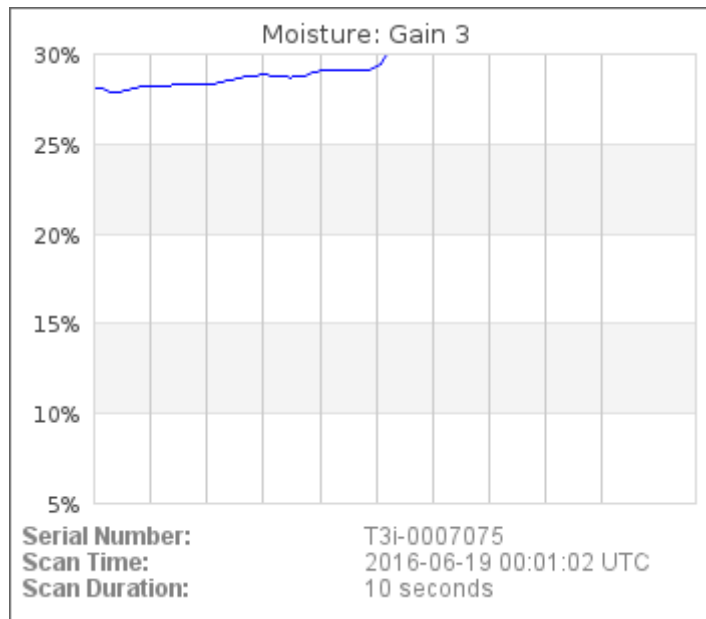
1.1 Moisture Scan

30% moisture compared to a area only 500mm away.

Scan Location: Exterior/Under Floor Area Void
Termatrac device was: Handheld
Termatrac device position: Flush against surface
Damage Visible: No

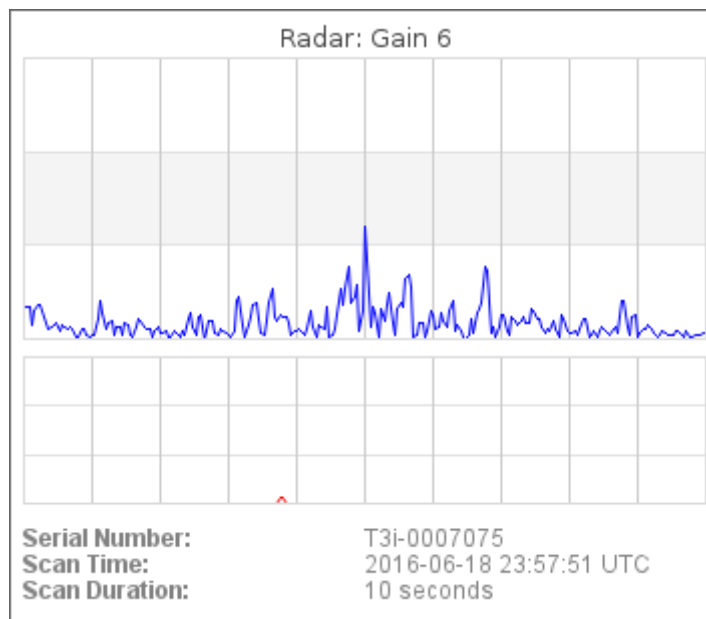
1.2 Radar Scan

High movement indicating positive termite activity to joist and bearer under bathroom

Scan Location: Exterior/Under Floor Area Void
Termatrac device was: Handheld

Damage Visible: No

Coptotermes found in beam and joist - with the entry point found. Nest underground was not detected or found. Recommend baiting system as per the attached proposal.

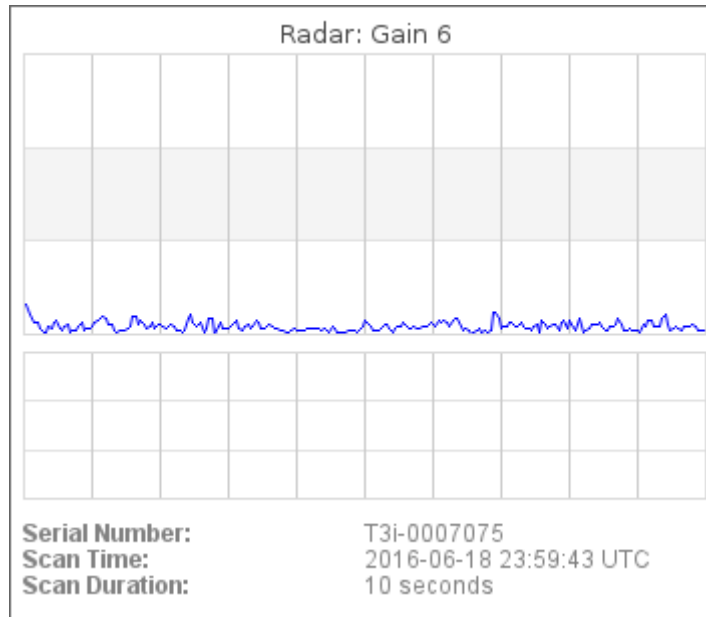
1.3 Radar Scan

moderate movement indicating termite trail.

Scan Location: Exterior/Under Floor Area Void

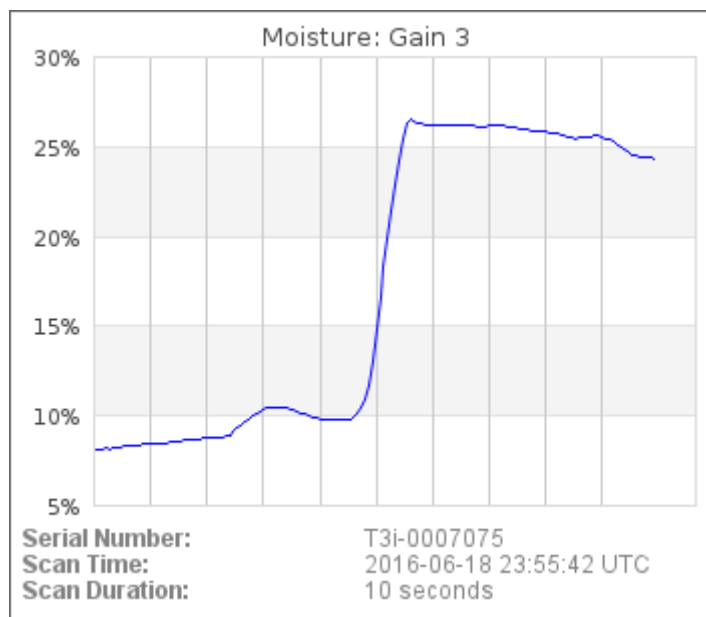
1.4 Moisture Scan

High moisture conducive to termite activity

Scan Location: Exterior/Under Floor Area Void

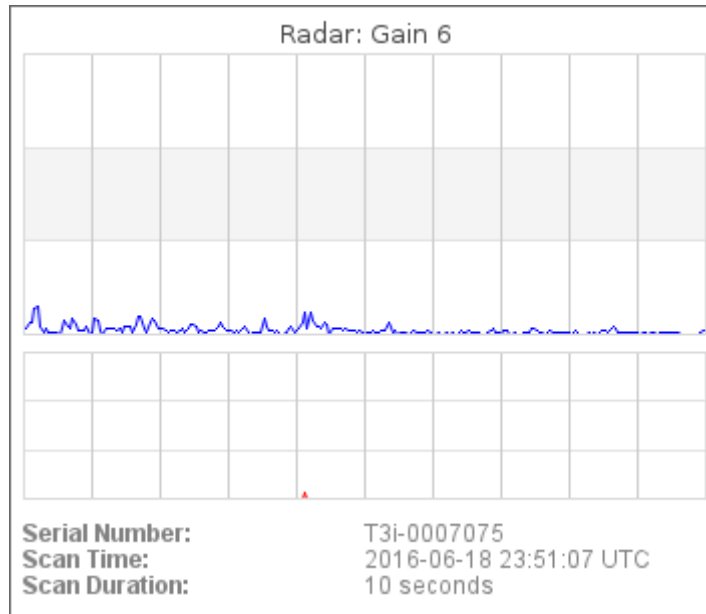
1.5 Radar Scan

Additional movement - termite activity recorded

Scan Location: Exterior/Under Floor Area Void
Termatrac device was: Handheld
Termatrac device position: Flush against surface
Damage Visible: No
