Visual Termite Inspection & Report in Accordance with AS 3660.2-2000

XXXXXXXX, Wyee New South Wales, 2259 Australia

Visual Termite Inspection Report in accordance with AS 3660.2-2000

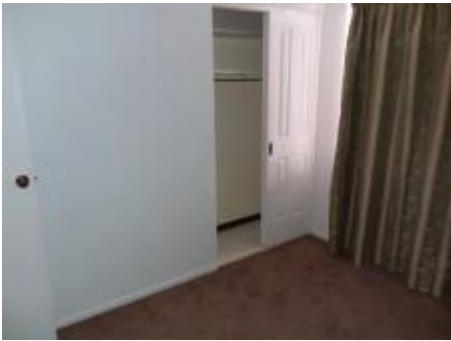
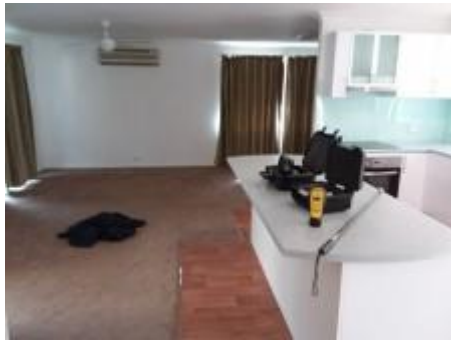
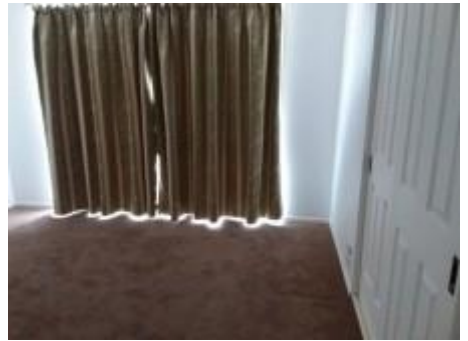
The main house was vacant at the time of inspection

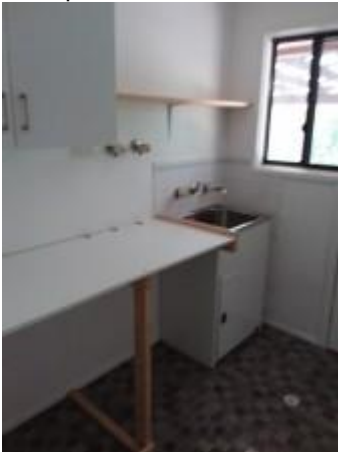
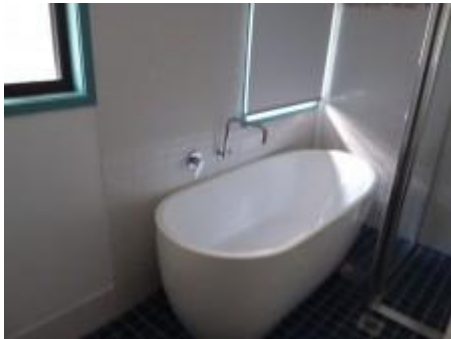
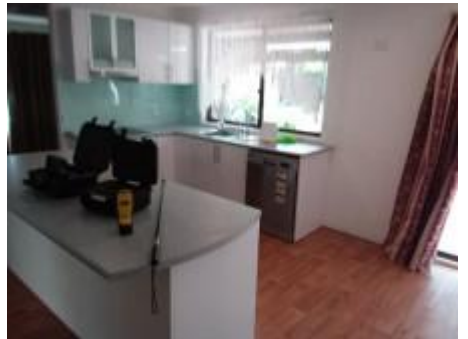
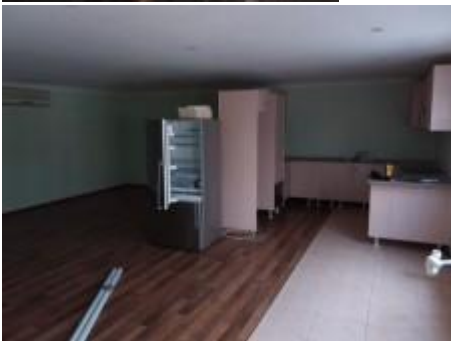
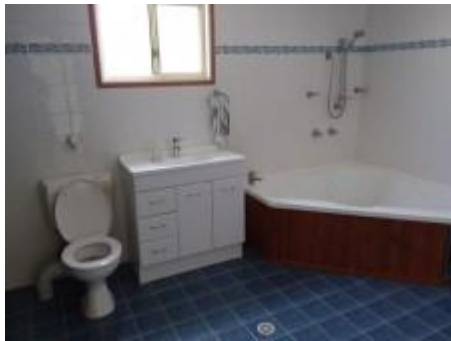
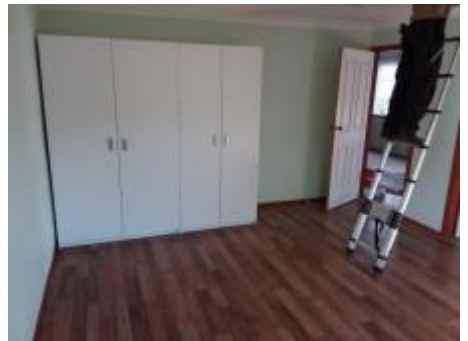
The granny flat was vacant at the time of the inspection

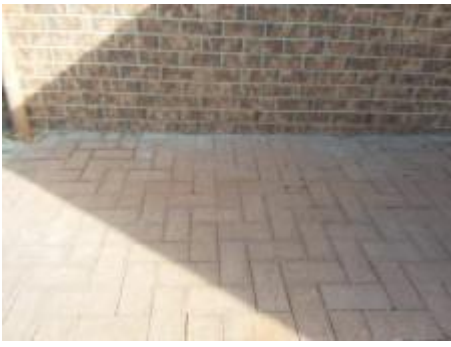
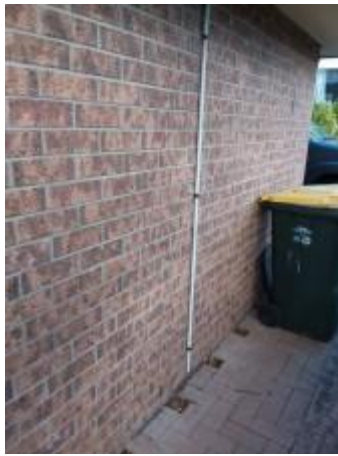
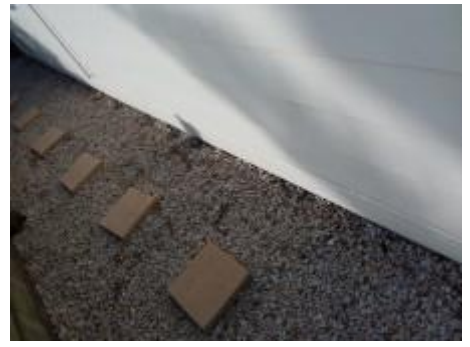
Slab Edge cover in certain areas to main house

Slab edge covered to granny flat

Does the slab edge inspection zone fully comply?	No, arrange for slab edge to be exposed
---	--

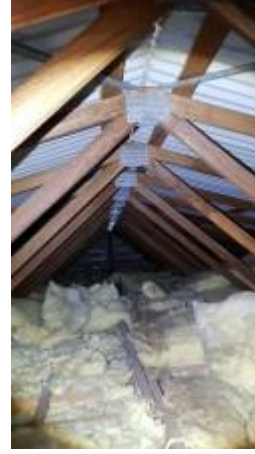
Roof void to granny flat

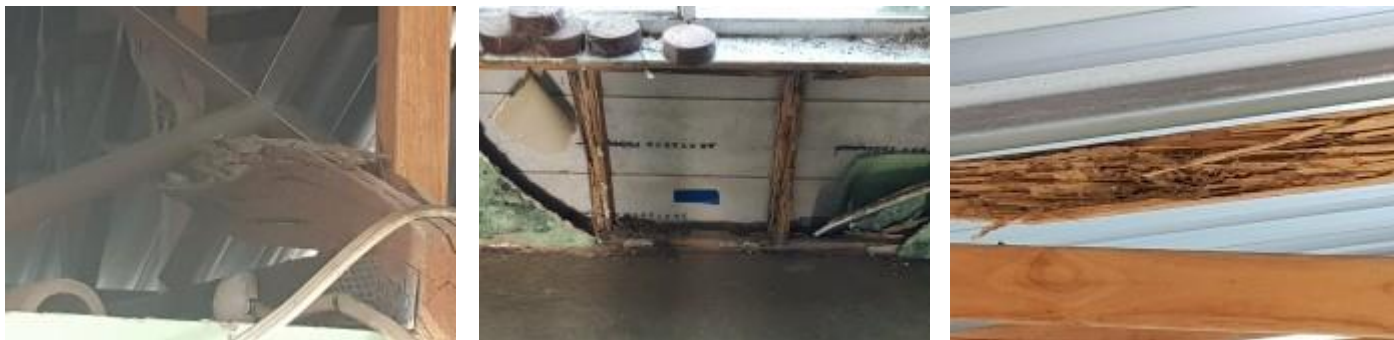
Extensive structural damage 2 old shed building

Environmental, other Conditions and/or general information: The old shed appears to be structurally damaged and is a OH&S issue. We recommend a structural engineer to assess the Integrity of this building further

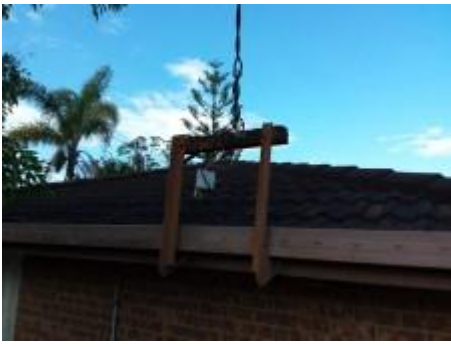
Severe wood rot to electric entry point to main house

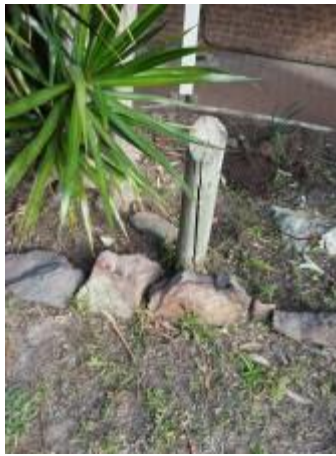
Weathering and slight wood rot to garden Timbers

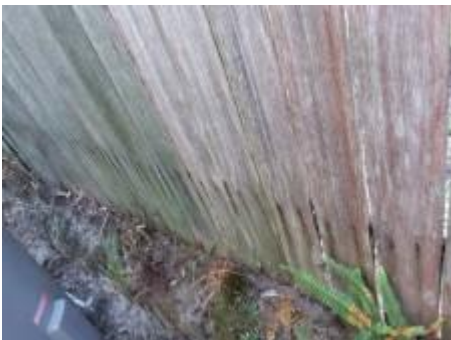
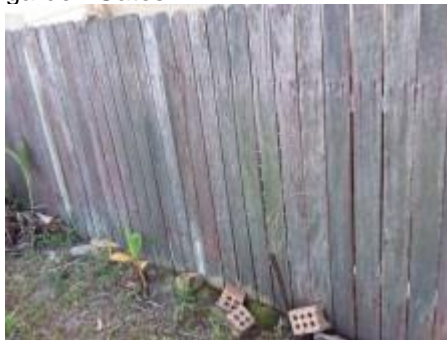
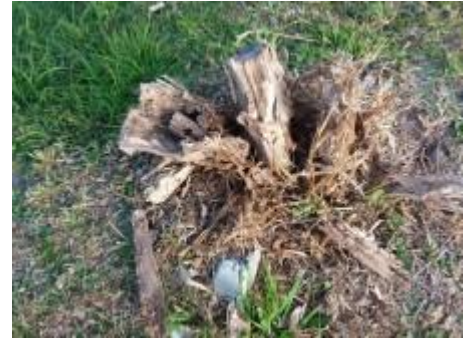
Wood rot to wooden fence line to left-hand side of property

Rotten tree stump to rear garden

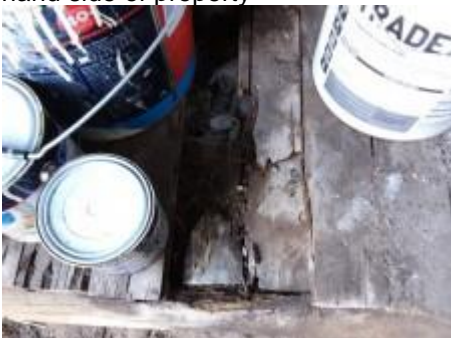
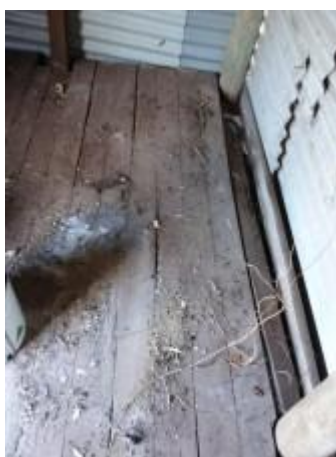
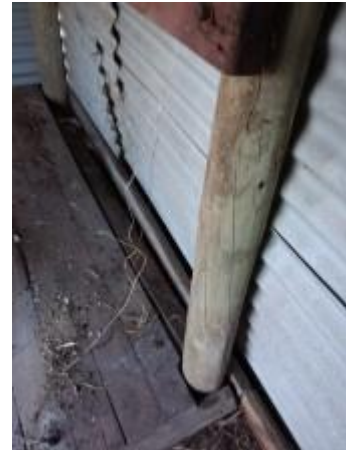
Wood rot to flooring in chicken shed

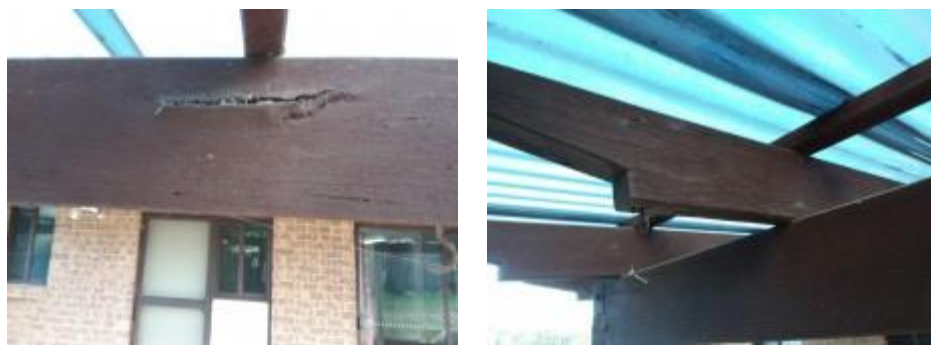
Slight wood rot to pergola covering rear patio

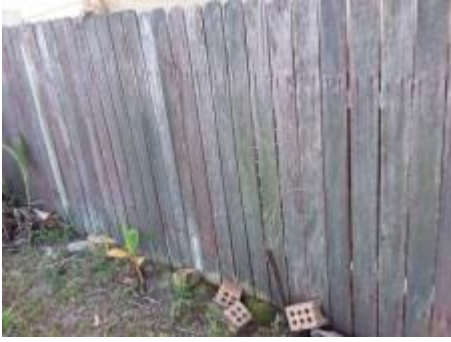
timber fence posts and fencing in direct contact with the ground and can attract termite activity

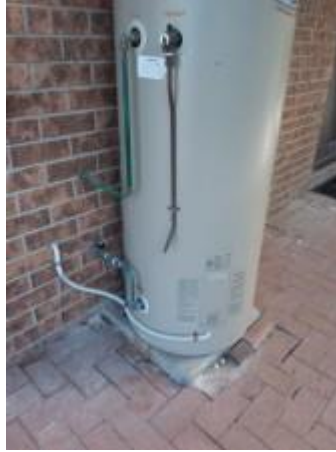
Hot water heater Overflow to the main house and the granny flat a dripping water to external walls this can attract termite activity due to moisture buildup recommend plumbing into drain

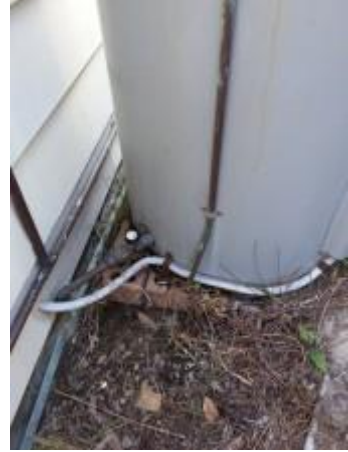
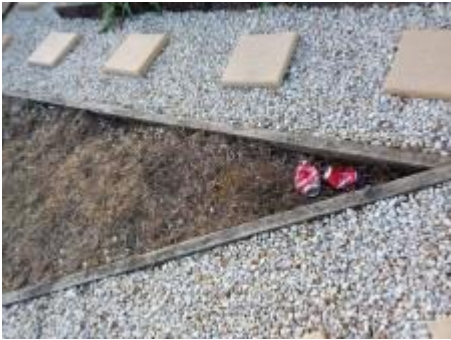
Garden Timbers are in direct contact with the ground and can attract termite activity

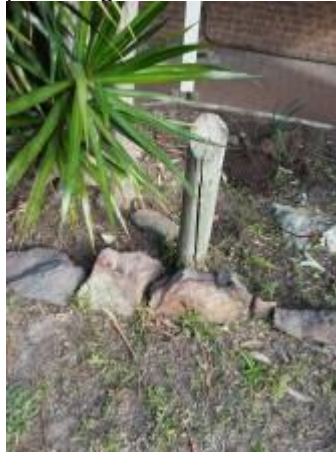
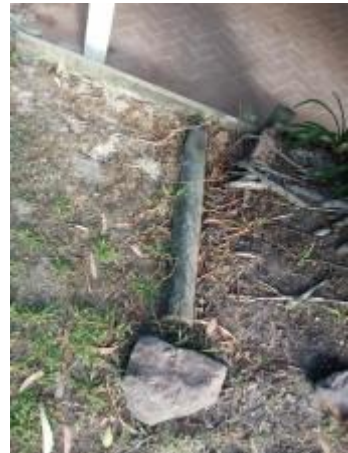
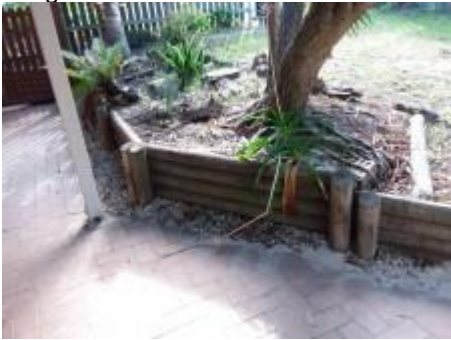
Wooden retaining walls are in direct contact with the ground and can hide termite activity to the property

Any Timber retaining walls should be replaced with non-susceptible material. You should consult a builder prior to removing/replacing retaining walls.

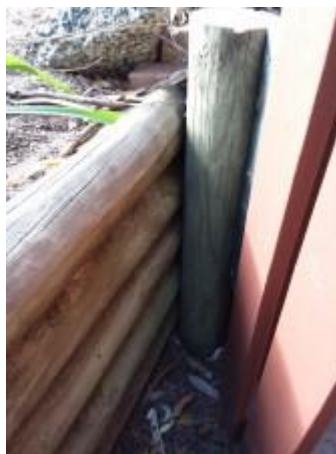
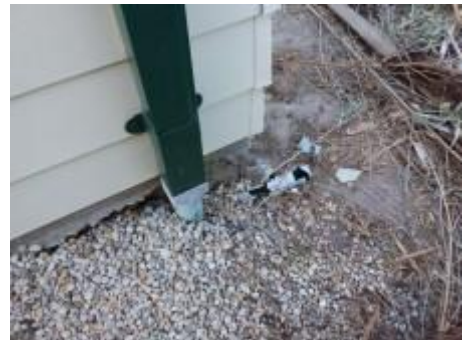
Whilst not a plumber, it appears that water leaks are	Present
Areas where leaks should be attended to by a plumber or other expert and why:	Downpipes to granny flat or damaged causing a moisture build up in the ground which can attract termite activity

Damaged down pipe drainage to granny flat

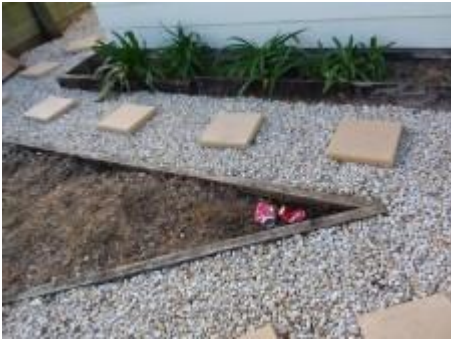
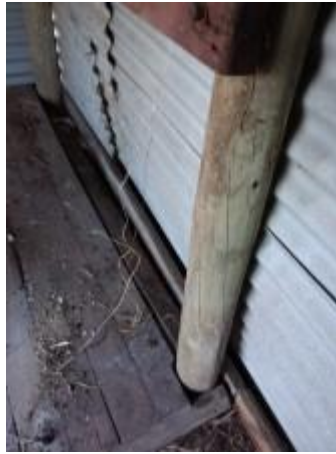
The chicken house structure is in direct contact with the ground and can attract termites

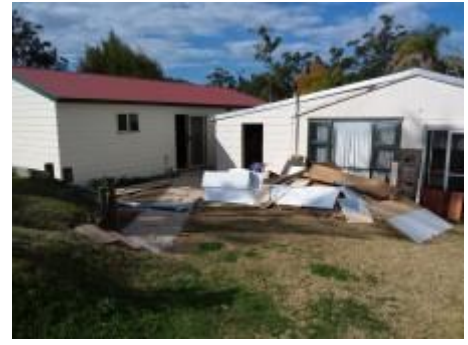
The old shed show signs of structural damage due to previous termite activity
