4 Eleanor St Hamlyn Terrace

## Pre-Purchase Standard Property Inspection Report

04th Aug, 2020

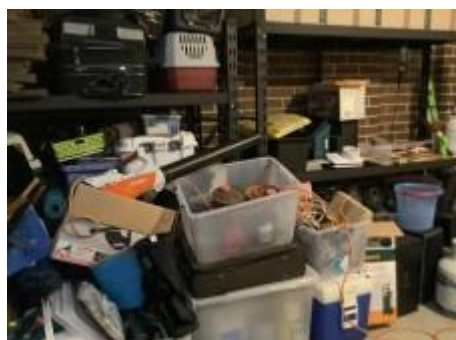
Stored Articles to Garage. Thermal & Sarking to Roof Void

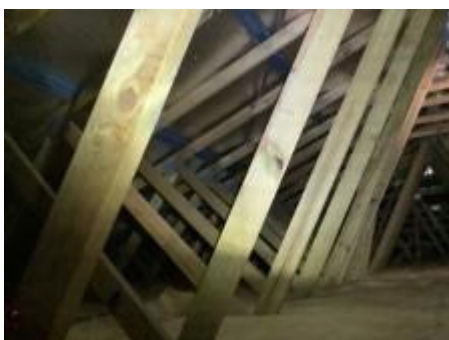
Stored Articles to Garage. Thermal & Sarking to Roof Void

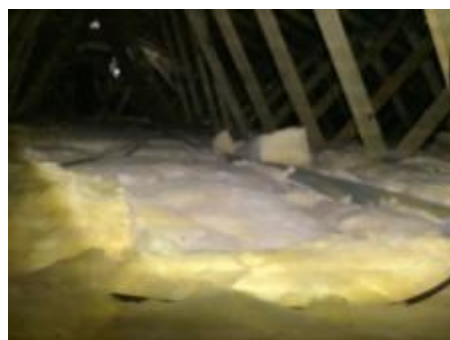
Stored Articles to Garage. Thermal & Sarking to Roof Void

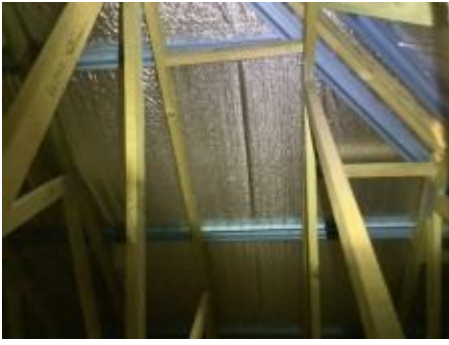
Stored Articles to Garage. Thermal & Sarking to Roof Void

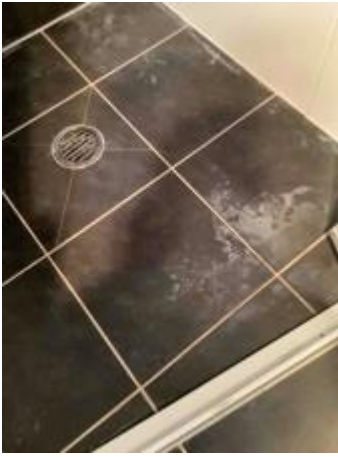
Discoloured Grout to Shower Floor

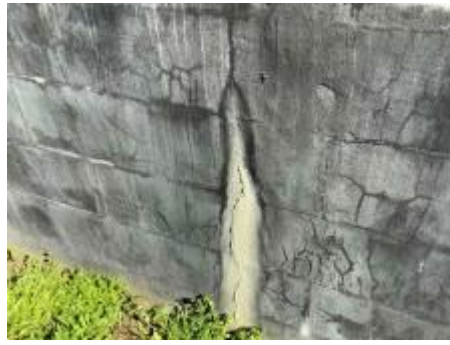
Minor water Ingress through rear retaining wall
