Visual Timber Pest Inspection & Report AS 4349.3-2010
(For use in all States & Northern Territory but not the Australian Capital Territory)

1** Smith Rd, Avoca Beach NSW

Inspection Date:	03-Jul-2020
Report Prepared Date:	03-Jul-2020

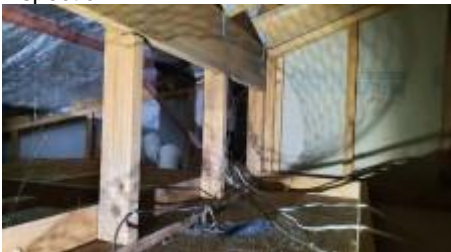
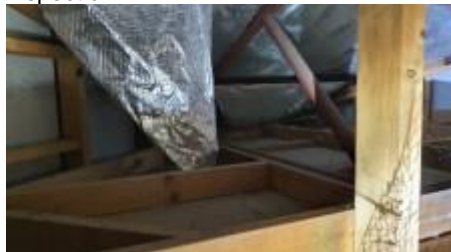
Limited access to roof void areas

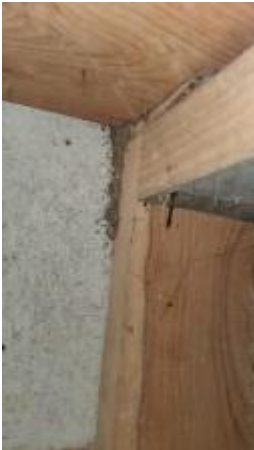
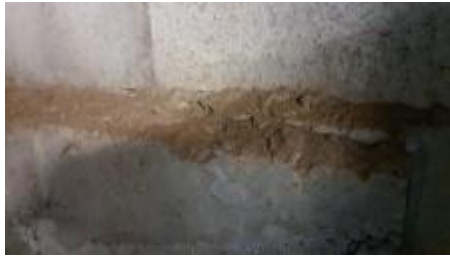
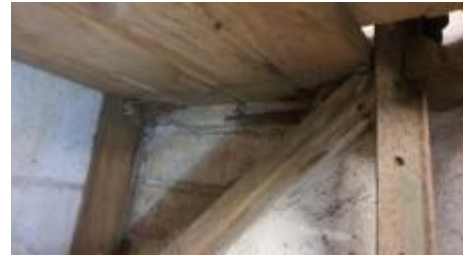
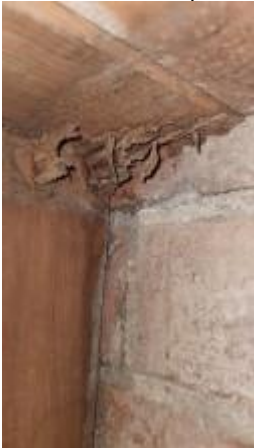
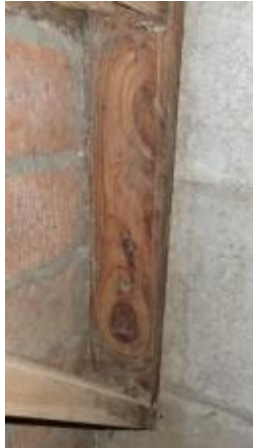
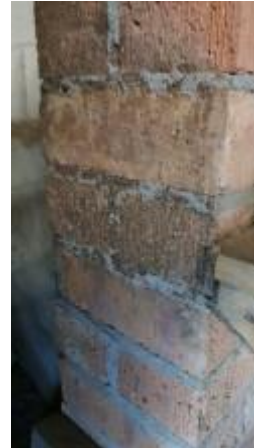
Visible evidence of subterranean termite workings and/or damage	was found
Where workings and/or damage was found, it was in but not necessarily limited to the following areas:	Subfloor

Very old workings located in subfloor/ workshop area.

General remarks: A more thorough INVASIVE INSPECTION is available (refer to section 9). Where any current visible evidence of Timber Pest activity is found it is strongly recommended that a more invasive inspection is performed. Trees and stumps on the property with a diameter more than 100mm have been visually inspected for evidence of termite activity to a height of 2m where access was possible and practical. It is very difficult, and generally impossible to locate termite nests since they are underground and evidence in trees is usually well concealed. We therefore strongly recommend that you arrange to have trees test drilled for evidence of termite nests.

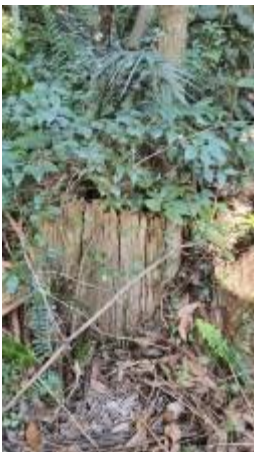
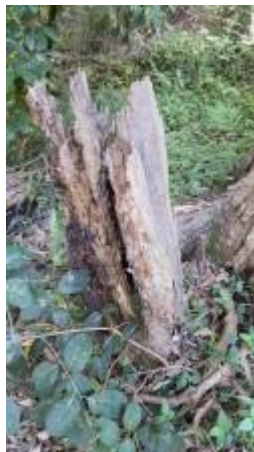
Woodrot to several stumps located around the property

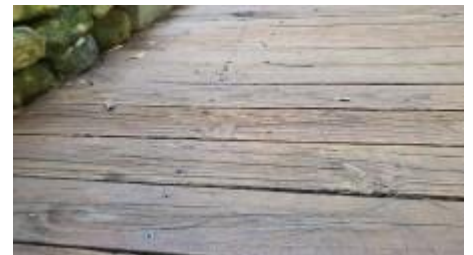
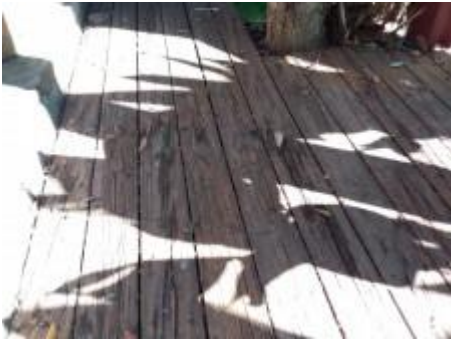
Weathering to decking areas

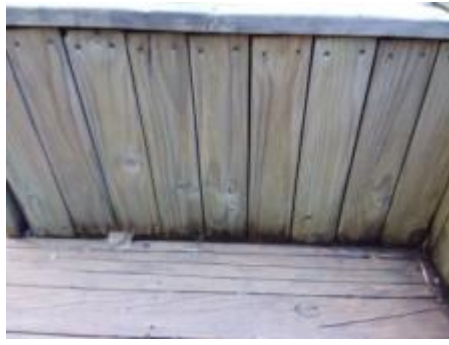
Slight woodrot and weathering to external timbers on decking areas

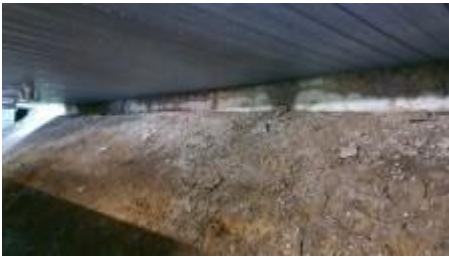
We claim no expertise in plumbing and drainage, however it appears that drainage is generally	inadequate. Increased water and moisture in the subfloor areas due to the sloping land from the front of the property
--	---

Where drainage is considered inadequate a plumber, builder or other building expert must be consulted.

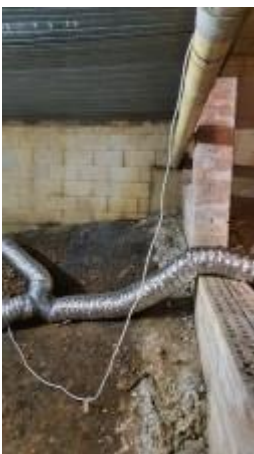
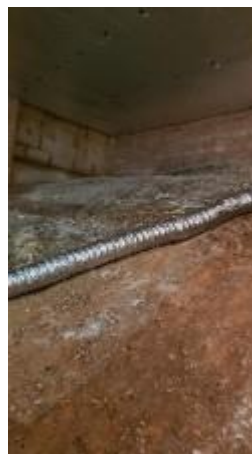
We claim no expertise in building, however, the ventilation appears to be generally	Inadequate
--	------------

Where ventilation is considered inadequate a builder or other expert should be consulted, in the case where vent airflow is physically blocked or restricted, the obstruction must be removed. Recommend additional fans to subfloor areas

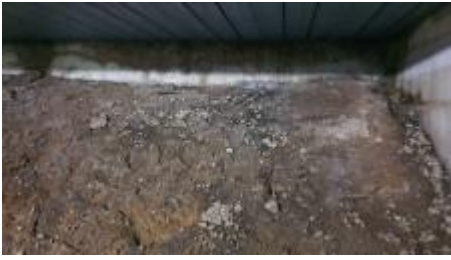
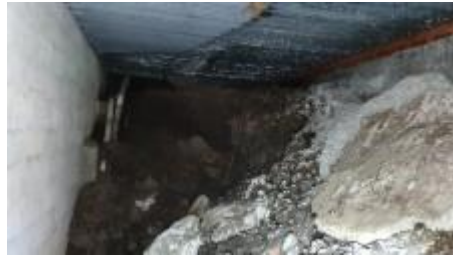
Mould	was found in the following area(s):. Subfloor areas
--------------	---

There is evidence of mould in the subfloor areas which may increase in wet weather

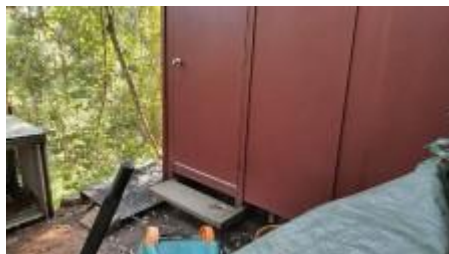
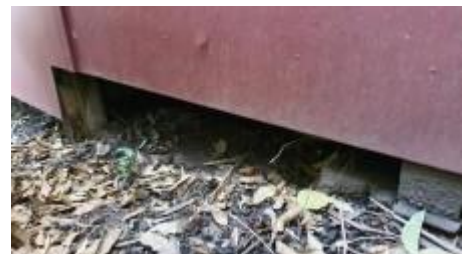
Carport/Shed is in direct contact with the ground and is conducive to termite activity and should be inspected on a regular basis for termite activity

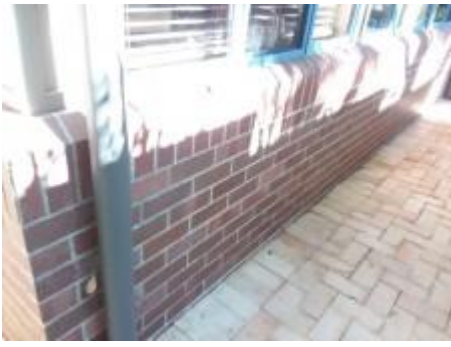
Slab edge is covered in several areas around the property should be exposed as this can hide termite activity entering the structure

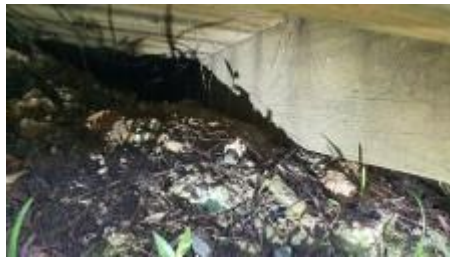
Rear Decking is built directly on the ground and should be inspected on a regular basis for termite activity and other pests

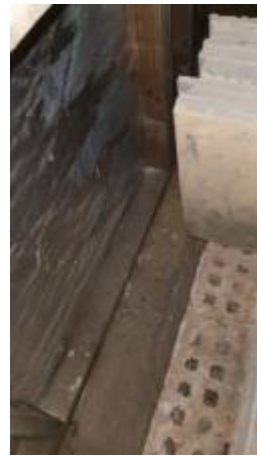
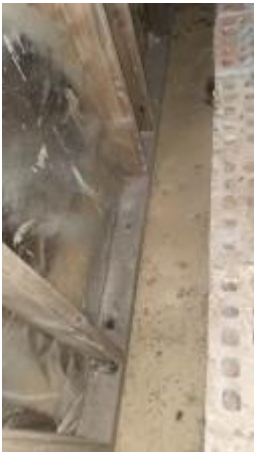
Lower level walls have no termite barriers and are installed directly onto the ground as seen from the subfloor areas, are conducive to termite activity and should be inspected on a regular basis

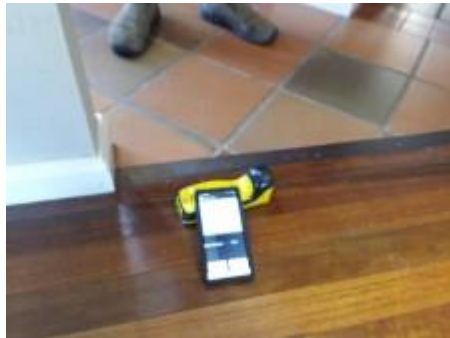
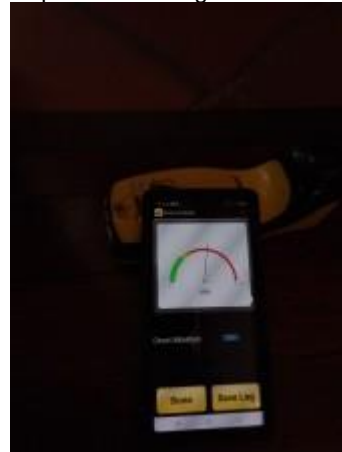
At the time of the inspection	high moisture readings were found in Dining room floors
--------------------------------------	---

Increased moisture readings to flooring in dining room and kitchen area

If high moisture was reported then you must have a building expert investigate the moisture and its cause and determine the full extent of damage and the estimated cost of repairs.
