Visual Termite Inspection & Report in Accordance with AS 3660.2-2000

XXXXXXXX, Wyee New South Wales, 2259 Australia

Visual Termite Inspection Report in accordance with AS 3660.2-2000

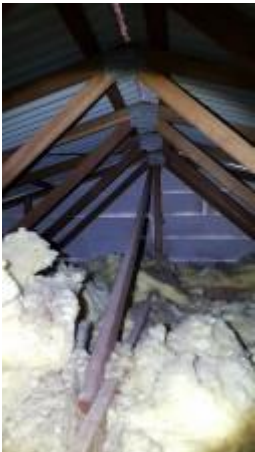
Roof void to granny flat

* Since a complete inspection of the above areas was not possible, termite activity and/or damage may exist in these areas.

Where insulation is present in the roof void it is recommended it be moved or removed and an inspection be carried out to the wall top plate timbers and other roofing timbers covered by the insulation. This invasive inspection will not be performed unless a separate contract is entered into.

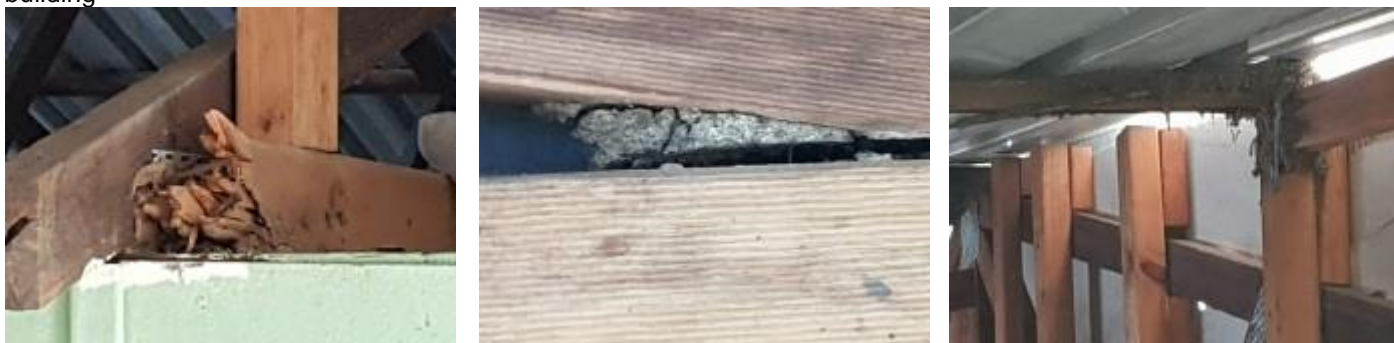
At the time of the inspection was visible evidence of subterranean termite workings located?	No
Was Termite damage located?	Yes
Termite workings and/or damage were found mainly in but not limited to:	Out buildings

Whilst we are not builders, the termite damage appears to be:	Extensive
--	------------------

Extensive structural damage 2 old shed building
